Work Order ID 149079

Item ID: D4634-145 Accept ***N900040100*** Setup Start ***NS1***
Revision ID: Stop ***NS2***
Item Name: Aft, Center Ceiling Replacement Panel Assembly
Start Date: 7/13/2016 Start Qty: 1.00 ***1*** Cust Item ID:
Required Date: 7/19/2016 Req'd Qty: 1.00 ***1*** Customer:
Reference:

D4634-145 AFT, CENTER CEILING REPLACEMENT PANEL ASSY

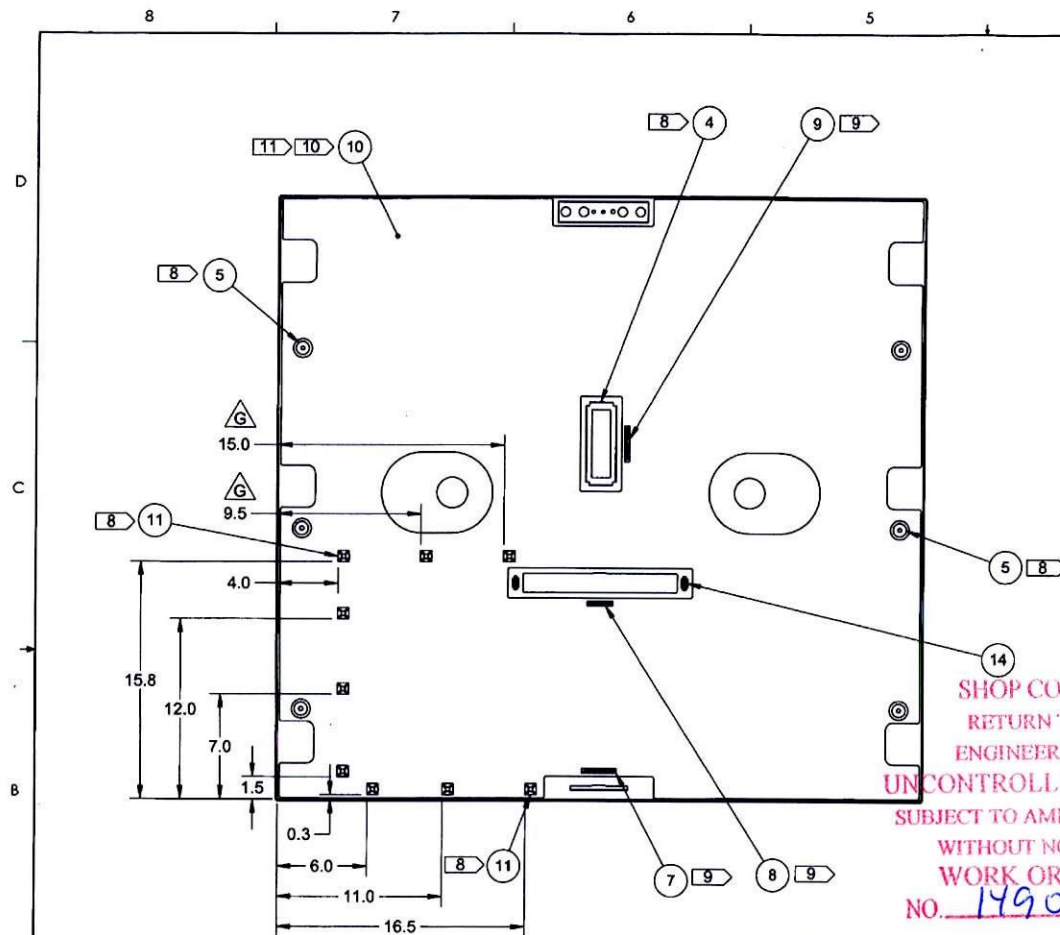
I saw the problems he was having and suggested to replace the rivets as a production tweek. I assessed the situation and suggested using an Anchor Nut Rivet (CCR264SS-3-03) when replacing the unacceptable rivet he showed me.

On the part which was brought to my concern there was superficial damage when he removed the rivet.
